Musculoskeletal disorder (MSD)

Arriva Trains Wales

Approach taken using the MAT Tool

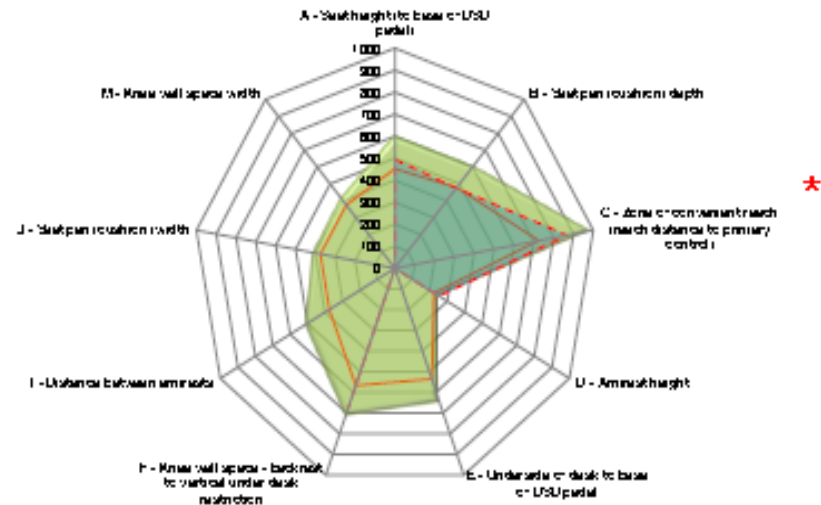
Holding check out:				Comparison with the anthropometric data of a measured individual									
	Dimensional (mm)		Percentage range covered		Female				Male					
	Min	Max	Female lo	Male	mm	%ile	F47	match	mm	%ile	F47	match		
A - Seat height	494	to	884	>99%	to	>99%			417	93%	No	-117	-217	
B - Seat pan depth (1000)	475	to	800	99%	to	>99%			479	97%	Yes	-	-20	
C - Zone of convenient reach (reach distance to primary control)	387	to	920	>99%	to	>99%			387	92%	No	-142	-205	
D - Armrest height	259	to	259	99%	to	91%			224	97%	No	-29	-29	
E - Underside of desk to footplate	0	to	845	>99%	to	>99%			500	99%	Yes	25	25	
F - Knee wall space - backward to vertical under desk restriction	875	to	110	>99%	to	>99%			875	110	9%	Yes	103	149
I - Distance between armrests	0	to	510	>99%	to	>99%			510	97%	Yes	125	125	
J - Seat pan width	0	to	411	>99%	to	99%			411	97%	Yes	26	26	
M - Knee wall space width	0	to	415	>99%	to	99%			415	97%	Yes	40	40
